Leakage around the “Center shaft” in the Spectra 20, 40, 60 and 100 models:

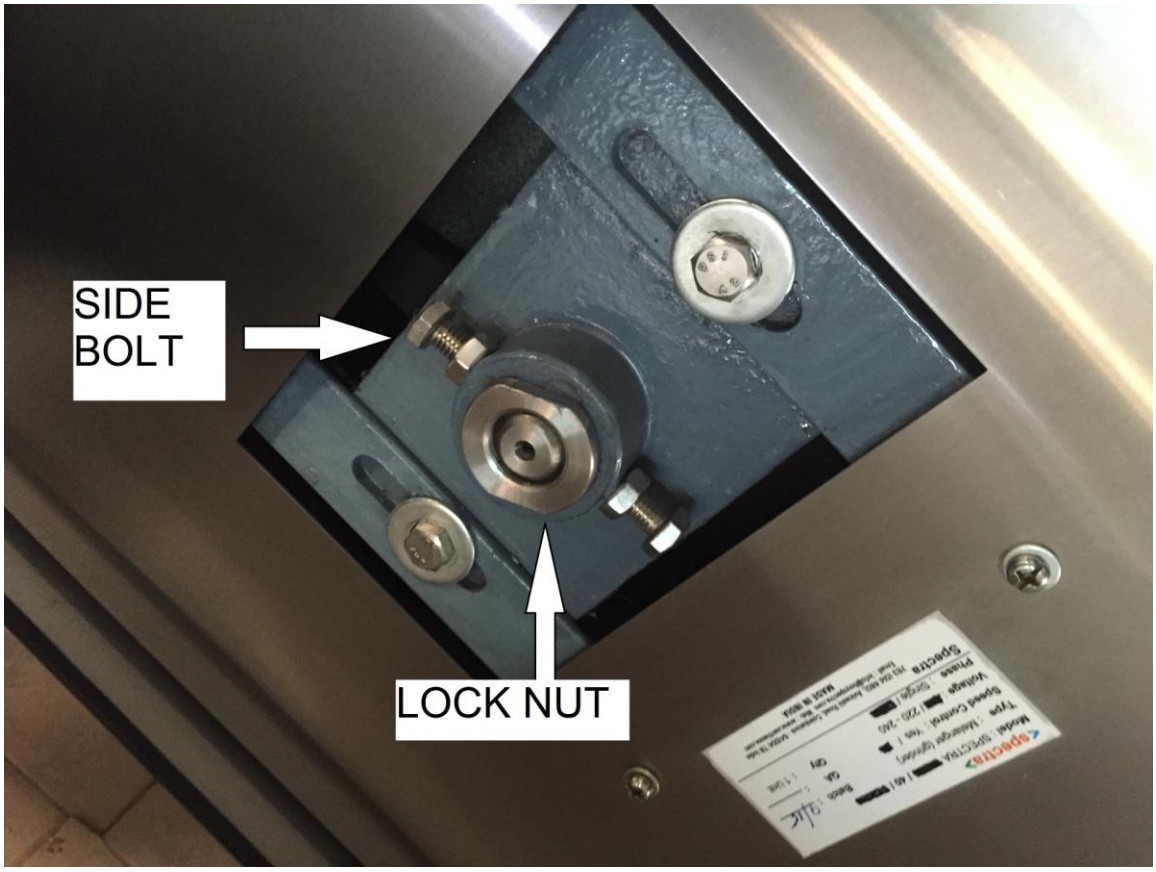
In case of a leak around the Central Stainless Steel shaft on any of these models, the cause is often arrested by tightening the Lock Nut at the bottom of the machine.

Remove the rollers stones off the machine.
Disconnect the machine from electrical power supply entirely.
Simply loosen the two Side bolts, then, tighten fully the LOCK NUT, and then retighten the two Side bolts, that are shown in the image below.

In case this does not arrest the fault, and the leak is only around the central shaft, then it may need disassembling and assembling back the central shaft and other components, which is a more involved process, and separate instructions are available for that.
