## Troubleshooting Guide CTTG #138

## Commander SK Trip and Status Diagnostic Codes

This document pertains to all Commander SK models

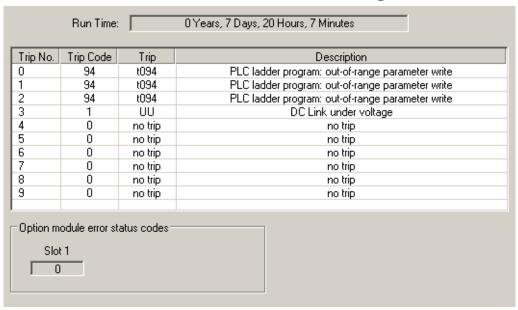
# The last 10 trips are recorded in chronological order of occurrence within the drive. This can be useful in overall diagnosis.
